National Transportation Safety Board

RRD22FR011

Group Chair's Factual Report

December 22, 2022

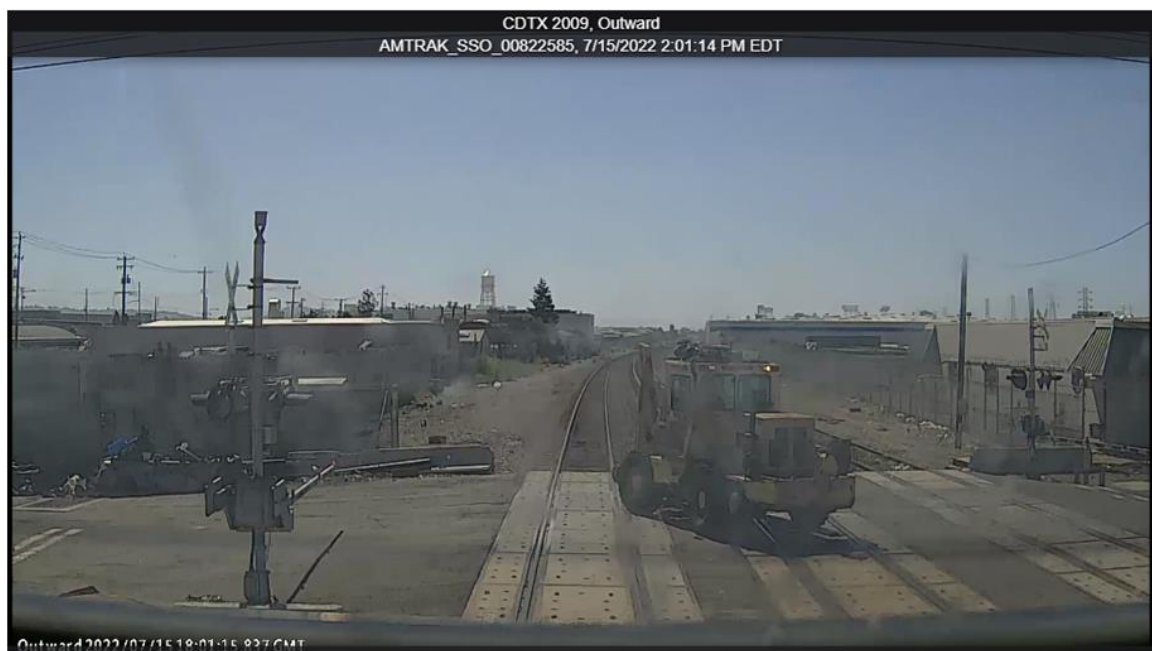
Figure 1. Screenshot from forward facing camera of CTDX Locomotive No. 2009

- 11:01:04 - Speed Swing in view on main track 1 with wheels parallel - Confirmed by use of the outward facing image recorder data by the operations group.

- 11:01:11 - First visual movement of speed swing on the crossing at 50th Ave - Agreed and confirmed by utilizing outward facing image recorder data by the operations group.

- 11:01:13 - Speed swing makes movement towards main track 2 - Confirmed utilizing outward facing image recorder data by the operations group.
- 11:01:13 - Final long whistle sequence begins at 1894 feet - Confirmed utilizing locomotive event recorder data by the operations group.

- 11:01:16 - End final long whistle sequence upon impact with speed swing at 50th Ave 1594 feet - Confirmed by utilizing both locomotive event recorder and outward facing image recorder data by the operations group. Train speed was 68 mph at this time - Confirmed utilizing locomotive event recorder data by the operations group.

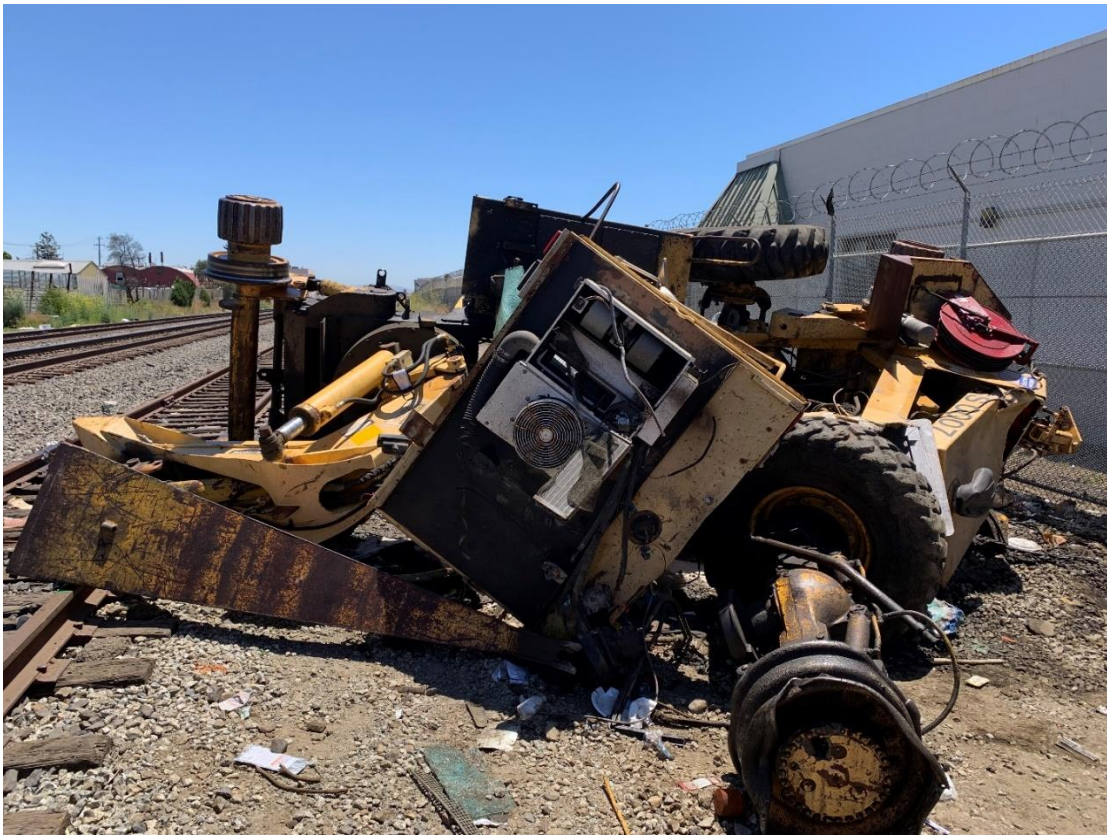
railroad right-of-way. The last recorded safety inspection of the subject speed-swing was on March 28, 2022. There was no record of a daily equipment inspection for the day of the accident found in the UP daily maintenance and inspection for work equipment log for the speed-swing that was recovered near the wreckage. The functional state of the equipment could not be determined due to accident damage.

Figure 3. Speed-swing SS-007 as found following impact and extrication.

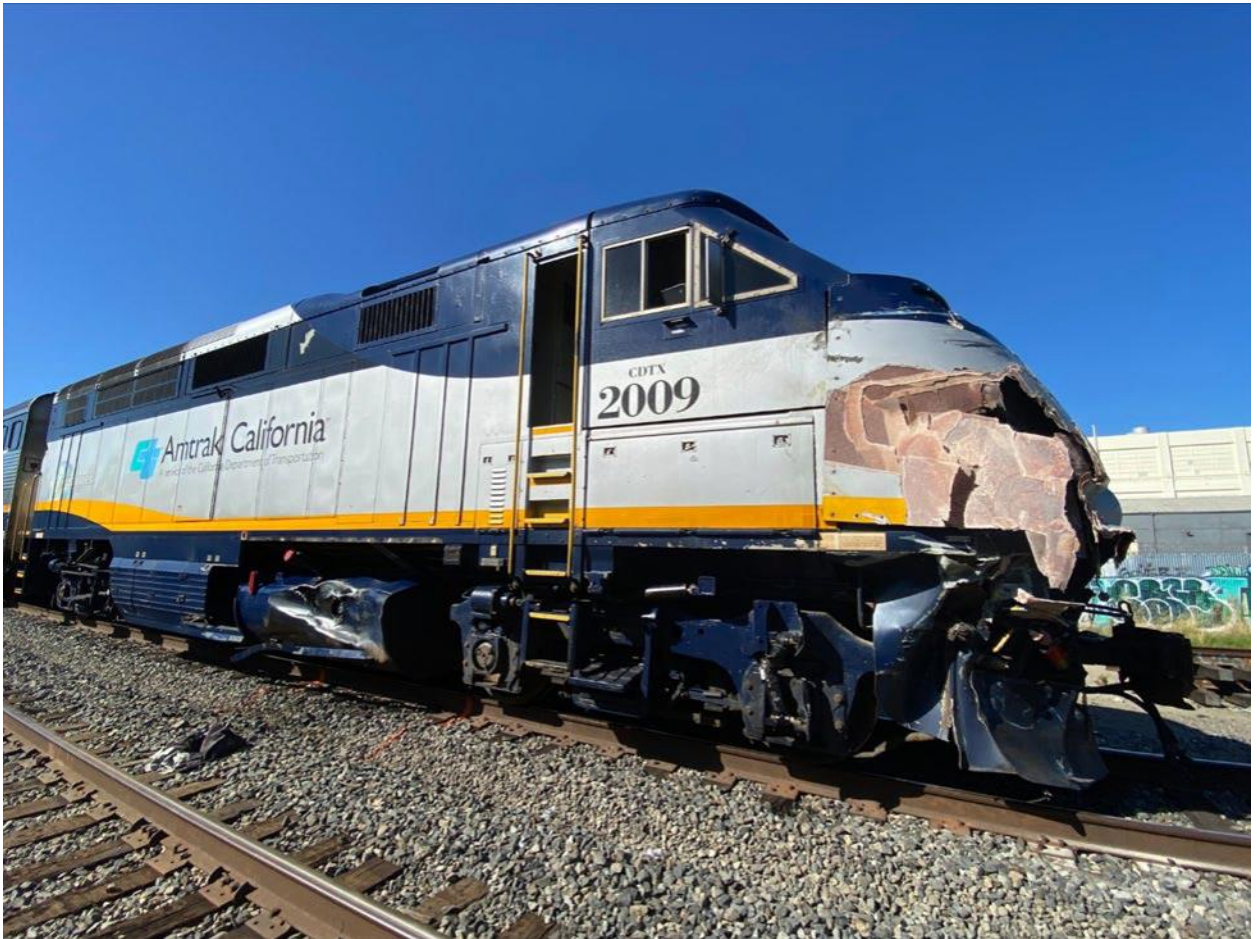
train was traveling 68 mph, when the engineer initiated an emergency brake application. The locomotive image recorder determined the train horn was activated on approach to the grade crossing. The RMM was destroyed, and the collision resulted in extensive damage to locomotive CDTX 2009 which included a fuel tank puncture and fuel release.

Figure 4. Photo of locomotive CDTX 2009 from Train 535-15 taken after the accident.

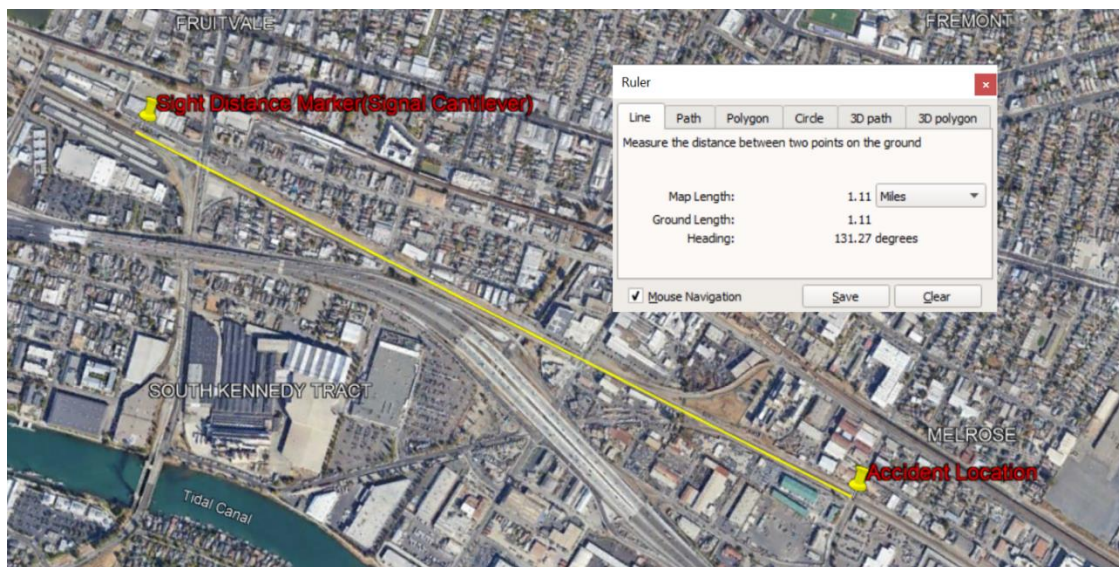
At the accident location, the maximum authorized train speed is 79 mph for Amtrak passenger trains and 60 mph for freight trains. Investigator determined that from the crossing, southbound trains could be seen at least back to Control Point East Oakland MP 9.6. The team determined that the minimum sight distance purview was over 1 mile.

Figure 5. Google Earth image showing sight distance estimation.
